# Pulp Mill's Hog Fuel Reclaim Wall repaired and protected for smooth operation

Industry: Pulp & Paper

Application: WPA-Wall Problem Areas

Customer Location: Port Alberni, BC

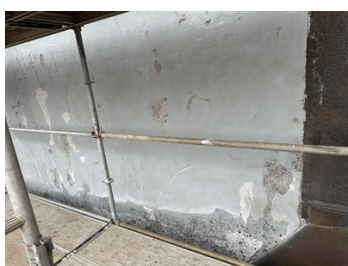
The mill load hog fuel for the boiler system. This 15-20 foot wall gets constantly loaded with hog to be sent the boiler via a conveyor system at its base. The wall was badly eroded and 'hang-ups' were occurring and this stopped the flow to the boiler. A slick finish was needed to allow the hog to slide freely to the conveyor below

Eroded and damaged wall.

Belzona 4111 was used 2/3 up the wall where the worst wear was present and two coats of Belzona 5821 Immersion Grade AR was apply.

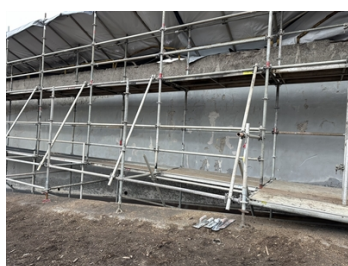
Damaged wall.

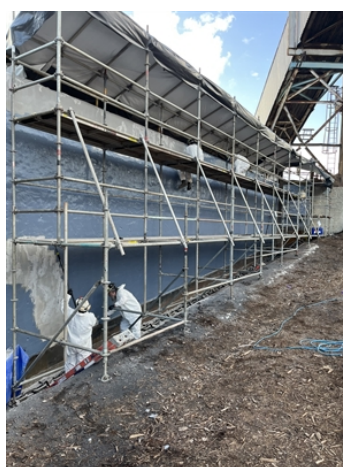
Application of Belzona 4111 to repair concrete.

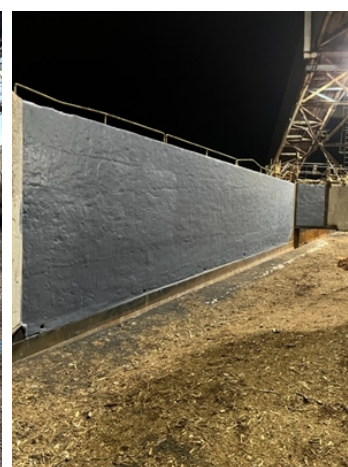
Finished application.

Other products were used and had failed in a short amount of time. The Belzona solution is working extremely well since the application
