# Activated Carbon Tank Hole Repair

ID: 9595

Industry: *Chemical & Petrochemical*  
 Application: *TCC-Tanks and Chemical Containment Areas*  
 Substrate: *Carbon steel*  
 Products: *Belzona 1111 (Super Metal)*

Customer Location: *Ontario*  
 Application Date: *September 2023*

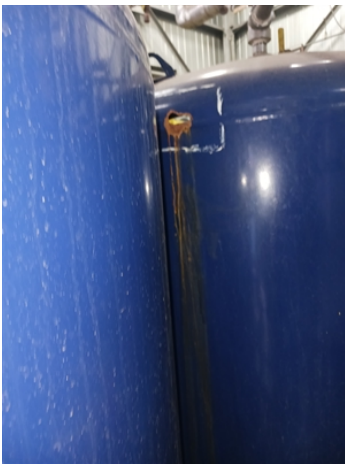
*Tank which contains activated carbon was wearing off the tank and caused a hole which requires repair.*

Tank showing hole defect.

The pH value of the activated carbon is causing deterioration of the tank which further caused a hole. Customer was advised to use bonding of a metal plate of close thickness to the tank on the hole and covered with Belzona 1111.

Surface cleaning of the tank and metal plate was done using power tool. An applicator was used to apply Belzona 1111 on the metal plate and bonded to the tank. Additional application of the product was done on the plate afterwards.

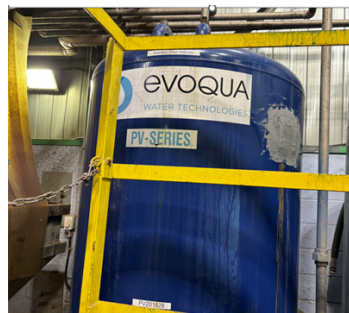
After repair.
