Activated Carbon Tank Hole Repair

ID: 9595

Industry: *Chemical & Petrochemical*
 Application: *TCC-Tanks and Chemical Containment Areas*
 Substrate: *Carbon steel*
 Products: *Belzona 1111 (Super Metal)*

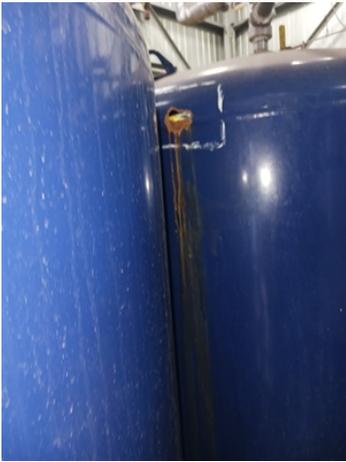
Tank which contains activated carbon was wearing off the tank and caused a hole which requires repair.

Tank showing hole defect.

The pH value of the activated carbon is causing deterioration of the tank which further caused a hole. Customer was advised to use bonding of a metal plate of close thickness to the tank on the hole and covered with Belzona 1111.

Surface cleaning of the tank and metal plate was done using power tool. An applicator was used to apply Belzona 1111 on the metal plate and bonded to the tank. Additional application of the product was done on the plate afterwards.

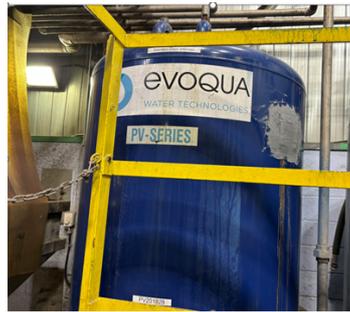
After repair.
