BELZONA® REPAIR OF POWER PUMP

ID: 96

Industry: Oil & Gas
Application: PDP-Positive Displacement Pumps

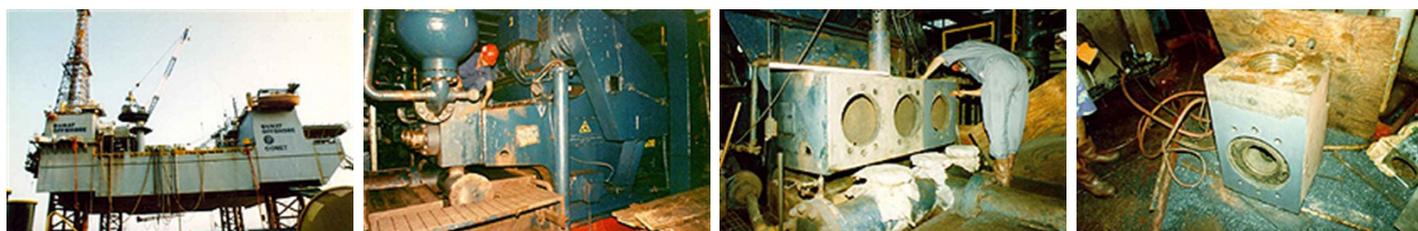
Corrosion of 2-4mm on the mating faces of the manifolds leading to leakage and loss of structural integrity

- * General view of the rig ,
- * The power pump ,
- * Application of Belzona to the pump casing ,
- * A re-faced flow block ,

Application was carried out in accordance with Belzona System Leaflet PDP-6.

Replacement pumps would have taken 6 months to deliver. Welding was not practical due to time required to accomplish. Belzona application cost \$12000 saving up to a million dollars.
