# Repair of the damaged wall and bottom of the boiler condensation container

ID: 9600

Industry: Heating, Ventilation & Air Conditioning  
Application: TCC-Tanks and Chemical Containment Areas  
Substrate: Carbon steel  
Products: Belzona 1511 (Super HT-Metal), Belzona 1593

Customer Location: Slovakia  
Application Date: August 2021

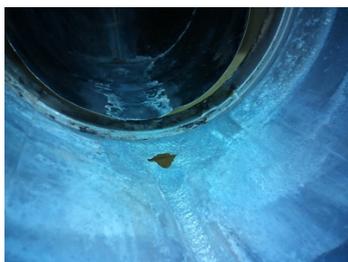
When using the Buderus condensing boiler, the bottom and walls of the boiler were damaged by corrosion.

Damaged bottom and walls of the boiler.

Corrosion caused damage to the bottom and walls of the boiler, making further use impossible.

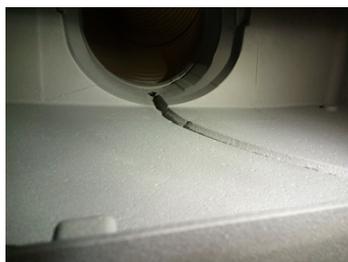
The surface of the damaged bottom and wall of the boiler had to be blasted before applying Belzona products.

Abrasive surface treatment, desalination, degreasing and inspection before application. Repair of the outlet thread. Application of the protective system with the material Belzona 1511 and 1593.

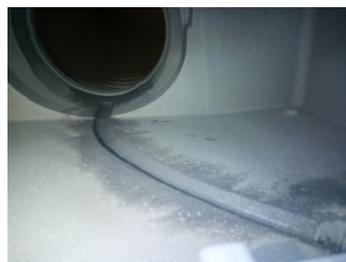
The missing original material was supplemented with the Belzona 1511 product.

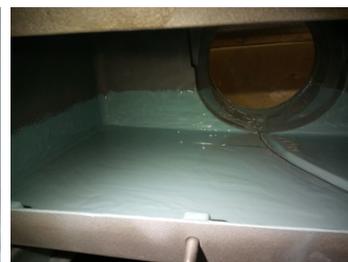
Both the bottom and the walls were treated with the product Belzona 1593.
