Anti-corrosive protection of the gutter on the water treatment plant.

ID: 9601

Industry: *Water / Wastewater*
Application: *TCC-Tanks and Chemical Containment Areas*
Substrate: *Carbon steel*
Products: *Belzona 5811 (Immersion Grade)*

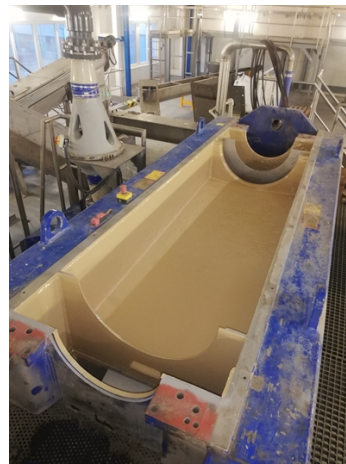
Application of the first layer of Belzona 5811.

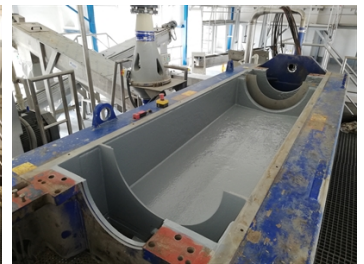
Application of the second layer of Belzona 5811.
