Belzona used for the repair and protection of the distributor head of the exchanger

ID: 9603

Industry: *Power*
Application: *HEX-Heat Exchangers*
Substrate: *Carbon steel*
Products: *Belzona 1391T, Belzona 1511 (Super HT-Metal)*

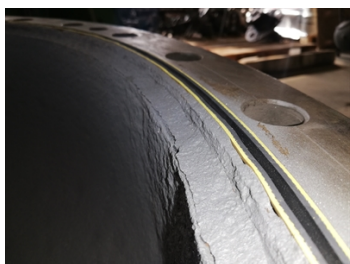
Damage to the distribution head of the exchanger causes poor distribution of hot water and a decrease in the efficiency of the exchanger.

Damage to the distributor head of the exchanger.

The hot medium and constant circulation caused damage to the dividers of the exchanger, which significantly reduced its performance. The customer was looking for a way to solve this problem.

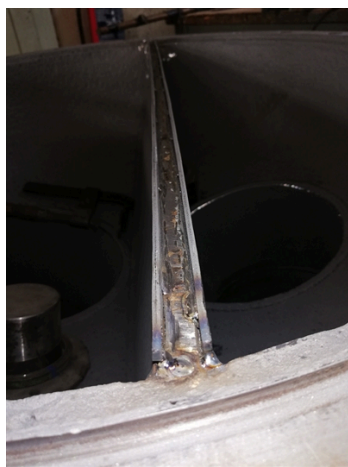
It was necessary to create new partitions.

Surface blasting to Sa 2.5 with a profile of 75 µm. Surface degreasing. Repair of the partitions of the distribution head by welding new steel bars. Application of Belzona 1511 (Super HT-Metal) on the most damaged parts
