Belzona used for the repair and protection of the distributor head of the exchanger

ID: 9603

Industry: *Power*
Application: *HEX-Heat Exchangers*
Substrate: *Carbon steel*
Products: *Belzona 1391T, Belzona 1511 (Super HT-Metal)*

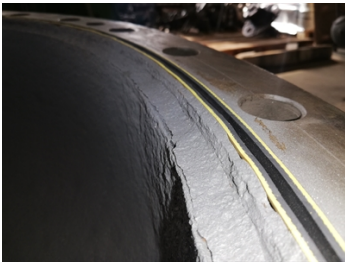
Damage to the distribution head of the exchanger causes poor distribution of hot water and a decrease in the efficiency of the exchanger.

Damage to the distributor head of the exchanger.

The hot medium and constant circulation caused damage to the dividers of the exchanger, which significantly reduced its performance. The customer was looking for a way to solve this problem.

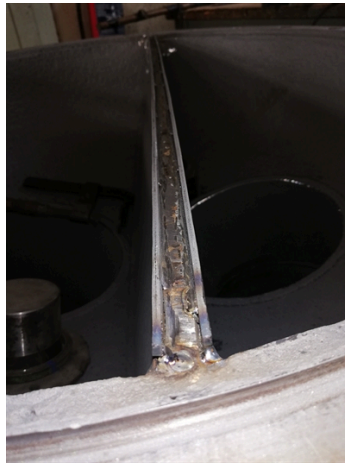
It was necessary to create new partitions.

Surface blasting to Sa 2.5 with a profile of 75 µm. Surface degreasing. Repair of the partitions of the distribution head by welding new steel bars. Application of Belzona 1511 (Super HT-Metal) on the most damaged parts

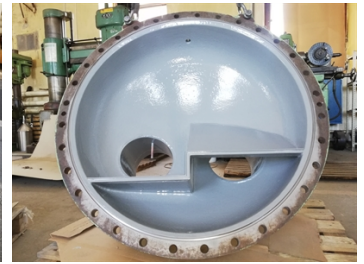
Belzona 1391T product application.

Application of Belzona 1391T in two layers with a total thickness of approx. 900 µm
