# Belzona used for the repair and protection of the distributor head of the exchanger

ID: 9603

Industry: *Power*  
Application: *HEX-Heat Exchangers*  
Substrate: *Carbon steel*  
Products: *Belzona 1391T, Belzona 1511 (Super HT-Metal)*

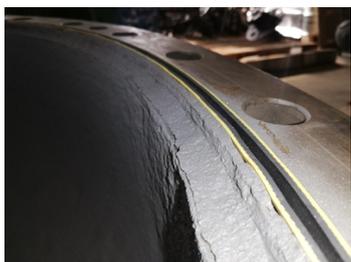
Damage to the distributor head of the exchanger.

The hot medium and constant circulation caused damage to the dividers of the exchanger, which significantly reduced its performance. The customer was looking for a way to solve this problem.

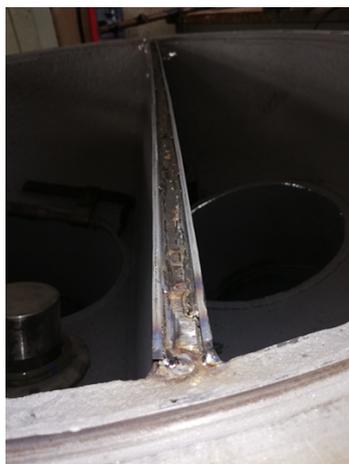
It was necessary to create new partitions.

Surface blasting to Sa 2.5 with a profile of 75 µm. Surface degreasing. Repair of the partitions of the distribution head by welding new steel bars. Application of Belzona 1511 (Super HT-Metal) on the most damaged parts

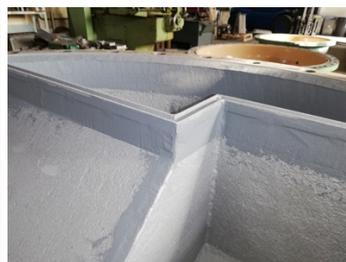
Replacement of the lost original material with the product Belzona 1511 (Super HT-Metal).

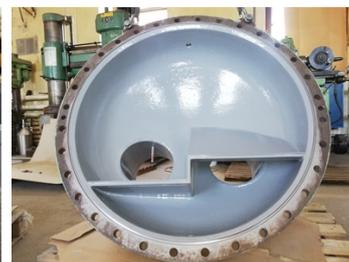
Belzona 1391T product application.

Application of Belzona 1391T in two layers with a total thickness of approx. 900 µm
