Belzona 1212 and Belzona 9621 stop the pulp water leak.

ID: 9604

Industry: *Pulp & Paper*
Application: *VPF-Valves, Pipes and Fittings*
Substrate: *Stainless-steel*
Products: *Belzona 1212, Belzona 9621*

Customer Location: *Oklahoma*
Application Date: *October 2024*

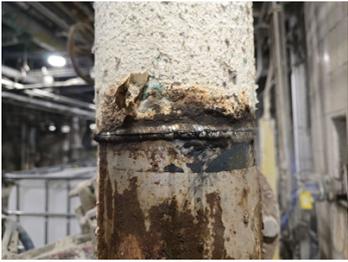
The stainless steel pipe seam had a defective weld allowing the pulp processing water to leak from the joint and had been for many years.

Original Condition.

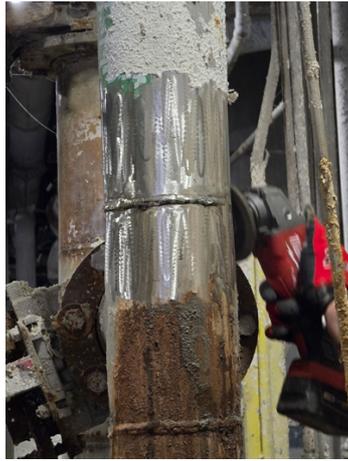
Removing the rust and pulp fiber and roughening the surface.

Battery powered grinder was used to both clean and prep the surface, and was washed down with solvent prior to the application.

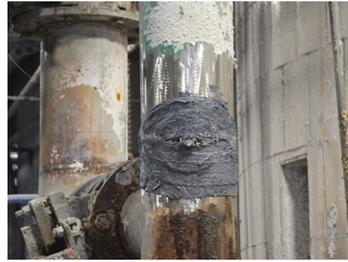
Belzona 1212, 9341, and 9621 in place.

This repair was able to be done because of the water tolerant capabilities of Belzona 1212. That allowed the repair to be completed while the water was leaking.

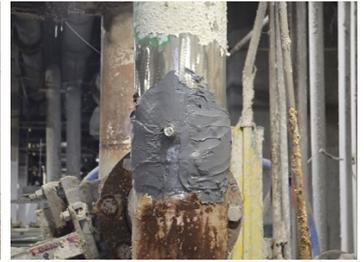
Final layer of Belzona 1212 applied.
