Repair of welds in stainless steel gutter.

ID: 9609

Application: TCC-Tanks and Chemical Containment Areas

Products: Belzona 1511 (Super HT-Metal), Belzona SuperWrap II

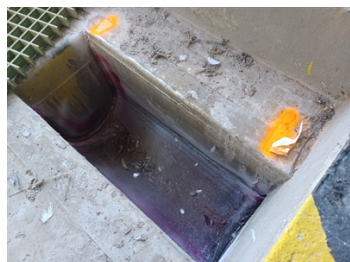
Damages in the gutter were detected with a test spray.

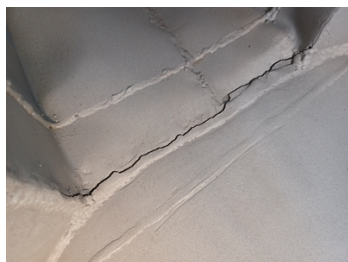
Cracks on the bottom of the gutter.
