Repair of welds in stainless steel gutter.

ID: 9609

Industry: Chemical & Petrochemical
Application: TCC-Tanks and Chemical Containment Areas
Substrate: Stainless-steel
Products: Belzona 1511 (Super HT-Metal), Belzona SuperWrap II

Customer Location: Slovakia
Application Date: September 2023

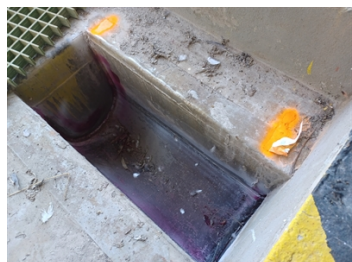
Damages in the gutter were detected with a test spray.
