Repair of welds in stainless steel gutter.

ID: 9609

Industry: *Chemical & Petrochemical*
Application: *TCC-Tanks and Chemical Containment Areas*

Substrate: *Stainless-steel*

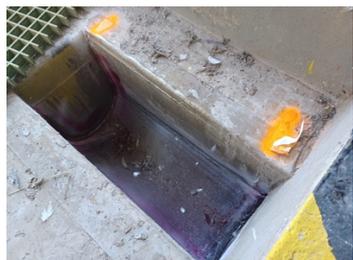
The welds started to crack in the stainless steel gutter.

Damages in the gutter were detected with a test spray.

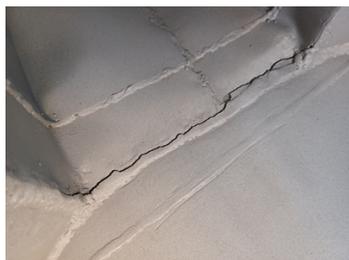
Cracks on the bottom of the gutter.
