Belzona applied to protect the bottom of the large tank against corrosion

ID: 9611

Industry: *Pharmaceutical* Customer Location: *Slovakia*
Application: *TCC-Tanks and Chemical Containment Areas* Application Date: *April 2019*
Substrate: *Carbon steel*
Products: *Belzona 1111 (Super Metal), Belzona 5811 (Immersion Grade)*

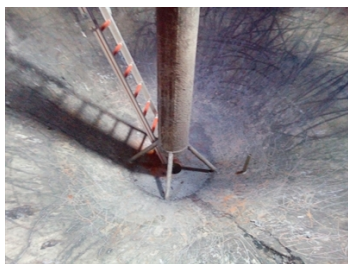
Damage appeared on the bottom of the tank due to corrosion.

Damaged tank bottom

Corrosion causes damage to the bottom of the tank and contamination of the processed product.

Surface blasting to Sa 2.5 with a profile of 75 µm. Surface degreasing. Application of Belzona 1111 (Super Metal) material to adjust the unevenness of the bottom surface. Application of the product Belzona 5811 (Immersion Grade) in two layers with a total thickness of approx. 500 µm.

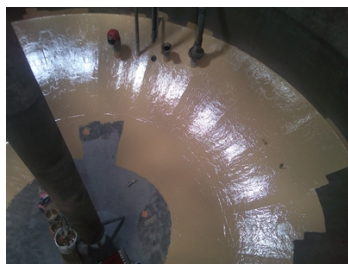
Application of the product Belzona 5811 (Immersion Grade) in the first layer.

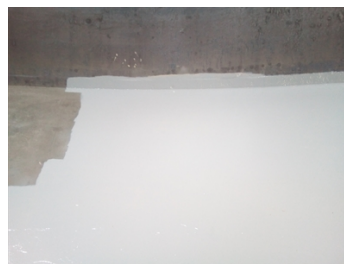
Application of the product Belzona 5811 (Immersion Grade) in the second layer.
