Belzona applied to protect the bottom of the large tank against corrosion

ID: 9611

Industry: *Pharmaceutical*
Application: *TCC-Tanks and Chemical Containment Areas*
Substrate: *Carbon steel*
Products: *Belzona 1111 (Super Metal), Belzona 5811 (Immersion Grade)*

Customer Location: *Slovakia*
Application Date: *April 2019*

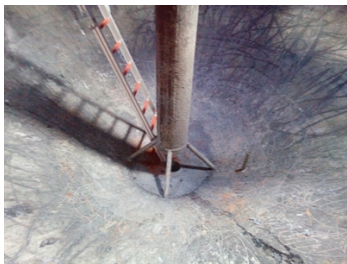
Damage appeared on the bottom of the tank due to corrosion.

Damaged tank bottom

Corrosion causes damage to the bottom of the tank and contamination of the processed product.

Surface blasting to Sa 2.5 with a profile of 75 µm. Surface degreasing. Application of Belzona 1111 (Super Metal) material to adjust the unevenness of the bottom surface. Application of the product Belzona 5811 (Immersion Grade) in two layers with a total thickness of approx. 500 µm.

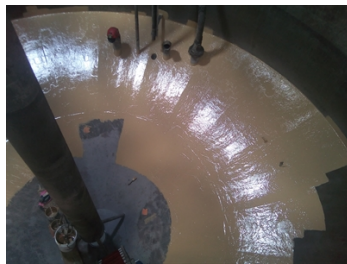
Application of the product Belzona 5811 (Immersion Grade) in the first layer.

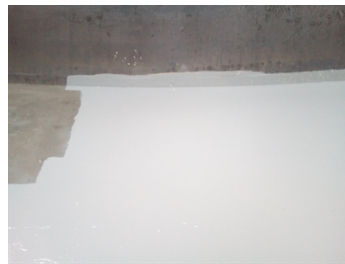
Application of the product Belzona 5811 (Immersion Grade) in the second layer.
