# Belzona 4341 rescues the Fibroc pump

Industry: *Fluid Flow* Customer Location: *Washington*  
 Application: *CEP-Centrifugal Pumps* Application Date: *October 2017*  
 Substrate: *Composite*  
 Products: *Belzona 4341 (Magma CR4), Belzona 4911 (Magma TX Conditioner)*

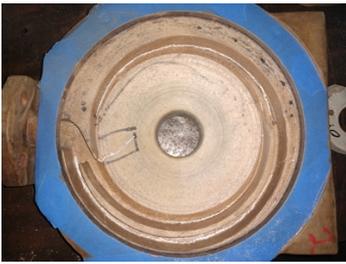
*This outdated pump had several cracks, fractures, damaged areas, and worn areas.*

Original condition. The black markings indicating where the cracks and fractures are.

Carefully sandblasted the pump to clean and roughen the composite surface, and then washed with solvent. Belzona 4341 was carefully weighed out to ensure the material would perform as needed. Belzona 4341 was applied by brush.

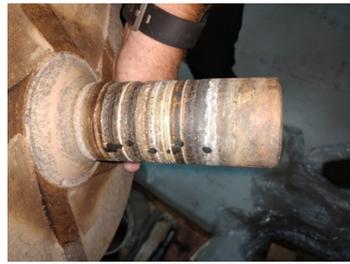
Shaft showing heavy uneven wear.

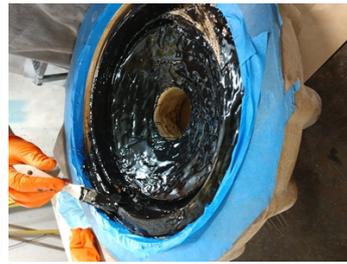
Application of Belzona 4341.

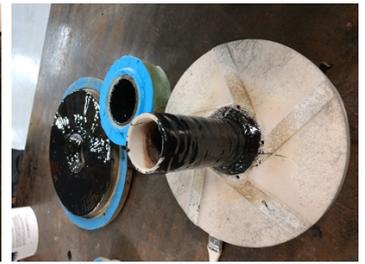
Showing some of the pieces with the application complete.

The cost of the Belzona materials for this pump was less than 10% of replacing it and reworking an entire production area to accommodate a new pump. With the heat, abrasion, and chemical resistance of the Belzona 4341, this was the perfect solution. This pump was still in operation 18 months later.
