Electric motor shaft repair

ID: 9616

Industry: *Power*
Application: *MPT-Mechanical Power Transmission*

Substrate: *Carbon steel*
Products: *Belzona 1111 (Super Metal)*

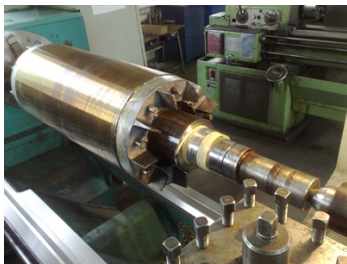
Damaged shaft under the bearing.

The shaft belongs to an electric motor with a power of 315 kW, manufacturer MEZ

Due to long-term use of the electric motor, the shaft was damaged. The customer was looking for a quick and high-quality solution. Our company has very good results with such repairs.

Machining the shaft to the required profile. Application of the product Belzona 1111. Curing. Processing the product Belzona 1111 to the required size.

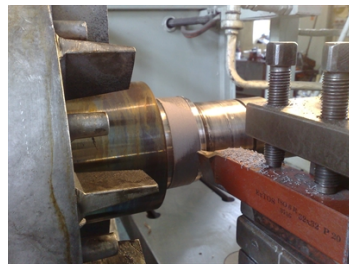
Damaged shaft under the bearing.

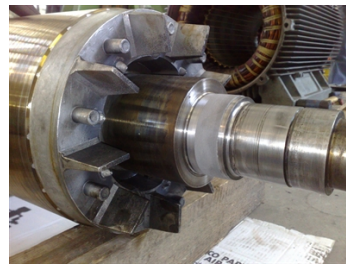
Processing of Belzona 1111 product
