Electric motor shaft repair

ID: 9616

Industry: *Power*
Application: *MPT-Mechanical Power Transmission*

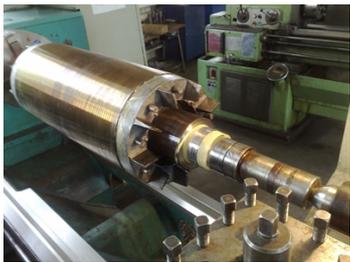
Damaged shaft under the bearing.

Due to long-term use of the electric motor, the shaft was damaged. The customer was looking for a quick and high-quality solution. Our company has very good results with such repairs.

Machining the shaft to the required profile. Application of the product Belzona 1111. Curing. Processing the product Belzona 1111 to the required size.

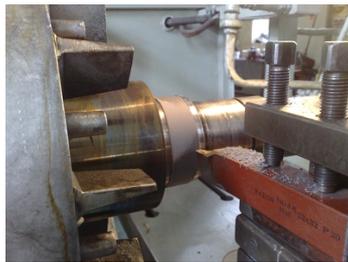
Damaged shaft under the bearing.

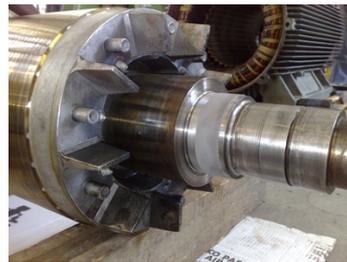
Processing of Belzona 1111 product

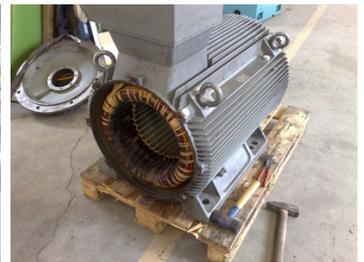
Repaired shaft

The shaft belongs to an electric motor with a power of 315 kW, manufacturer MEZ

This type of repair (using the Belzona 1111 product) is one of the fast and high-quality solutions. Also, there is no thermal influence, as happened with welding.
