# Belzona cold plate bonds in flour silo

Application: *TCC-Tanks and Chemical Containment Areas*

Substrate: *Carbon steel*

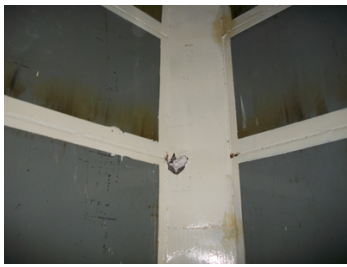
*Corrosion in flour silos had lead to through wall defects*

Corroded area

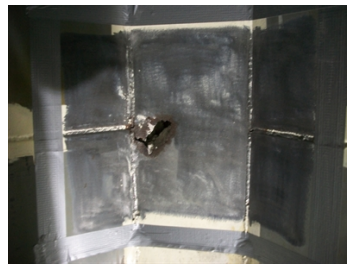
Preparation with MBX

A pneumatic MBX Bristle Blaster was used to prepare the metal surface. Plates were then bonded with Belzona 1111 to reinforce the holed areas. Two coats of Belzona 1341 were then applied to provide a low friction surface to prevent hand up of flour.

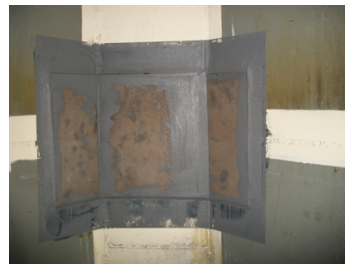
Plates bonded

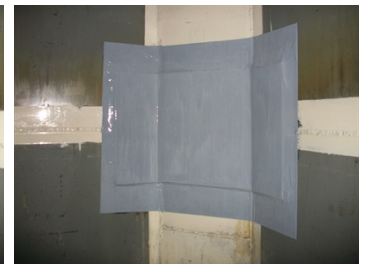
Overcoated with Belzona 1341
