Fan wheel repair

ID: 9619

Industry: *Cement*
Application: *FBC-Fans, Blowers and Compressors*

Substrate: *Carbon steel*
Products: *Belzona 1812 (Ceramic Carbide FP)*

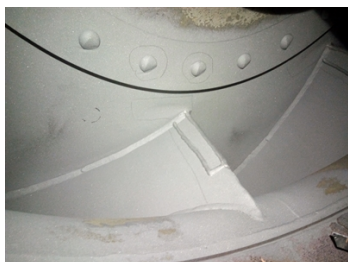
Wheel after blasting

Surface blasting according to the required Sa2.5 standard. Degreasing. Application of Belzona 1812 material on the cleaned surface of the device.

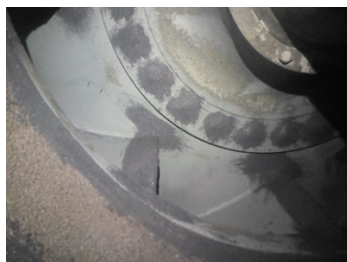
Application of the product
Belzona 1812 on the most
affected areas

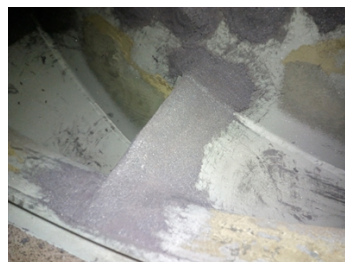
Application of the product
Belzona 1812 on the fan blade

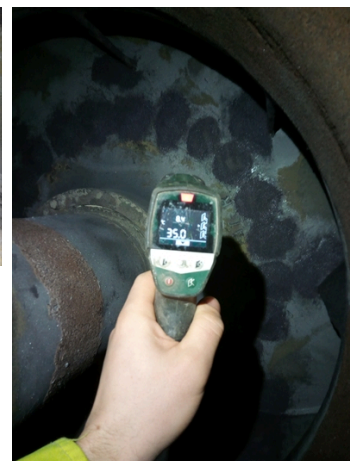
Since the repair was carried out
in the winter, the fan had to be
heated and the temperature
had to be controlled.
