Fan wheel protection against sticking

ID: 9620

Industry: *Cement*
Application: *FBC-Fans, Blowers and Compressors*

Substrate: *Carbon steel*
Products: *Belzona 1341 (Supermetalglide)*

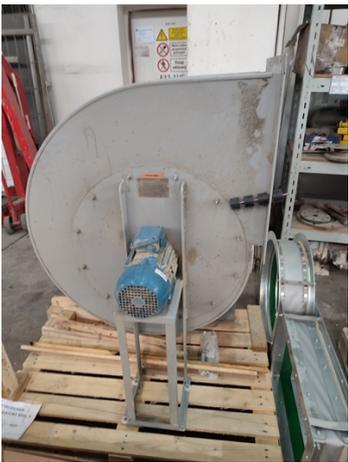
The sticky material caused the wheel to run erratically.

Fan wheel

Surface blasting according to the required Sa2.5 standard. Degreasing. Application of Belzona 1341 material on the cleaned surface of the device.

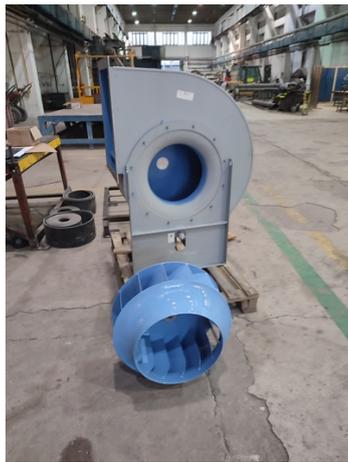
Application of the product
Belzona 1341 on the wheel

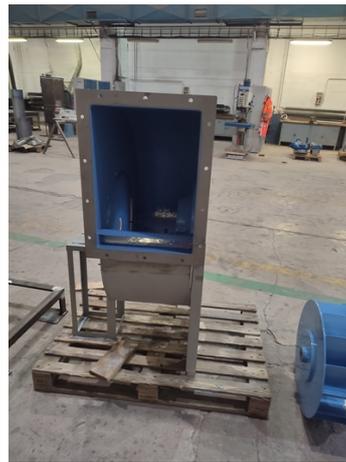
Application of the product
Belzona 1341 on the fan box

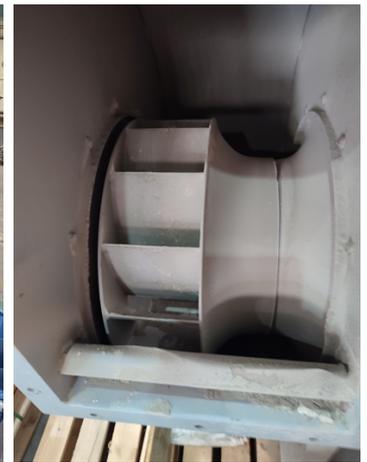
Fan wheel before repair

Irregular operation of the fan caused production interruptions and reduced equipment performance.
