7 Pumps For Belzona

ID: 9621

Industry: Water / Wastewater
Application: CEP-Centrifugal Pumps
Substrate: Cast Iron
Products: Belzona 1341 (Supermetalgilde)

Customer Location: North Idaho
Application Date: December 2017

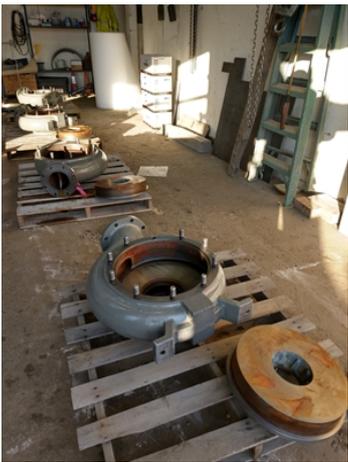
Brand new pumps ready to be coated.

The pumps and parts were grit blasted to a 5 mil profile, washed with solvent. Belzona 1341 was applied by brush.

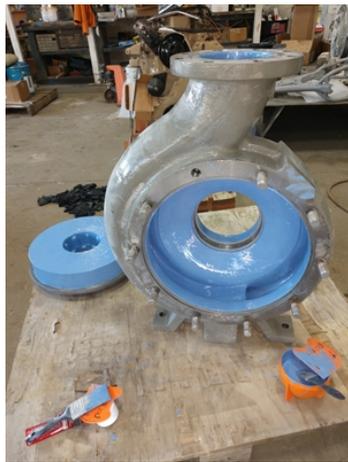
First coat of Belzona 1341 applied.

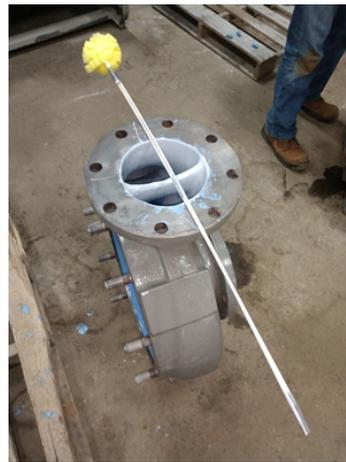
Applying the second coat of Belzona 1341.

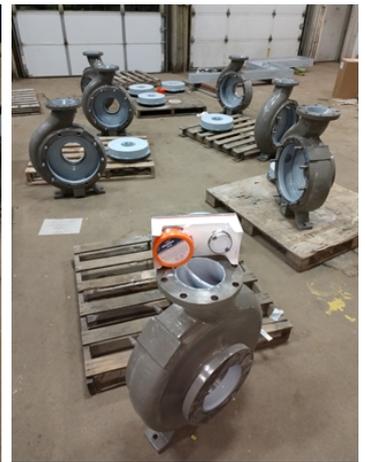
All 7 pumps completed.
