Pump plinth rebuild

ID: 9622

Application: *FPA-Floor Problem Areas*

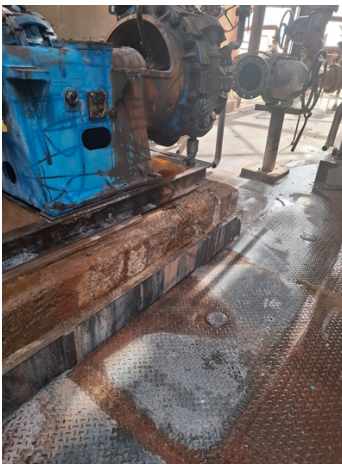
Over time the plinth surface had deteriorated due to constant contact with hot caustic.

Initial condition of plinth

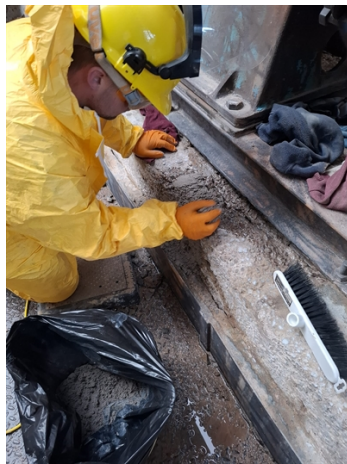
Application of Belzona 4131

4911 used as surface conditioner before application of 4131 which was used to rebuild profile of plinths.

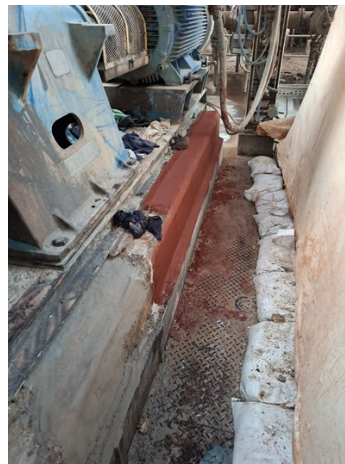
Application of Belzona 4181

4981 used as a conditioner before application of 4181 which will give resistance to caustic at elevated temperatures.

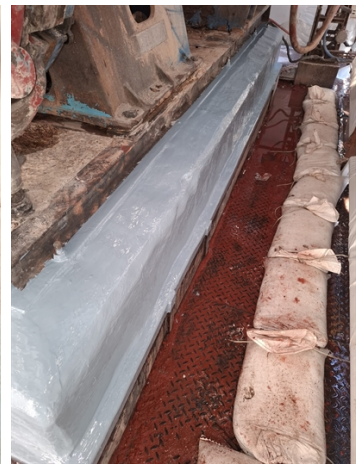
Overcoated with 1391T
