# Tank repair and protection

ID: 9626

**Industry:** Chemical & Petrochemical  
**Application:** TCC-Tanks and Chemical Containment Areas  
**Substrate:** Carbon steel  
**Products:** Belzona 1111 (Super Metal), Belzona 5892

**Customer Location:** Slovakia  
**Application Date:** March 2023

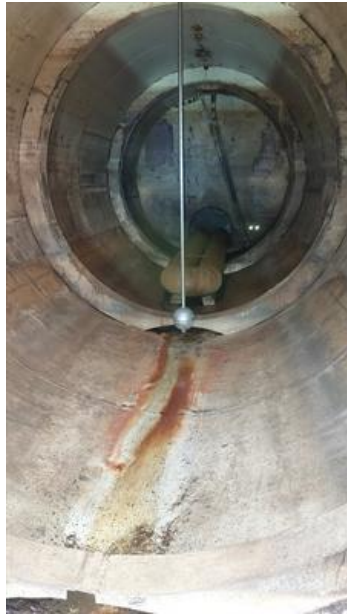
General view of the tank

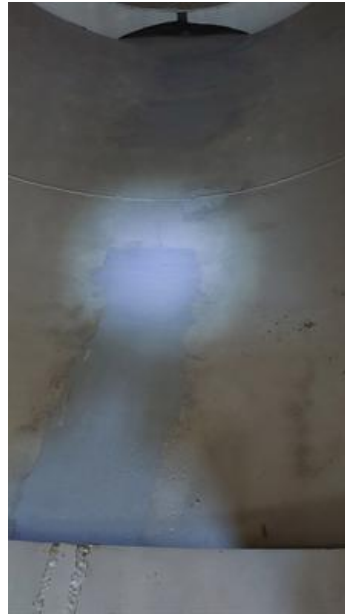
Corrosion damaged the bottom of the tank and there was a danger that the bottom of the tank would break through.

Damaged tank bottom

After a long time and due to aggressive chemicals from crude oil, the bottom of the tank was damaged. There was even a hole in the tank.

Surface blasting to Sa 2.5 with a profile of 75 µm up to the height of 1/3 of the shell.

Surface degreasing. Bonding of a metal plate to the bottom of the tank under the heating body (leakage at the bottom of the tank) with Belzona 1111.

Application of the product Belzona 5892 in a thickness of approx. 500 µm. Hardening of the material - by additional heating.
