Refurbishment of Drinking Water Split Casing Pump

ID: 9628

Application: CEP-Centrifugal Pumps

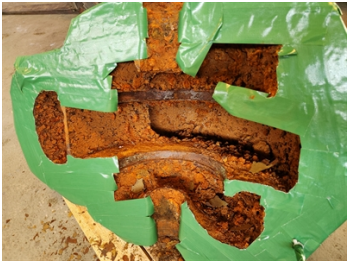
Customer faced corrosion and erosion in the casing of drinking water pump and it was unusable before Belzona repair.

Pump condition before application

For the surface preparation, the pump was blasting to remove all the rust and contamination from the surface, achieving a minimum profile of 75 microns and Near White Metal cleanliness.

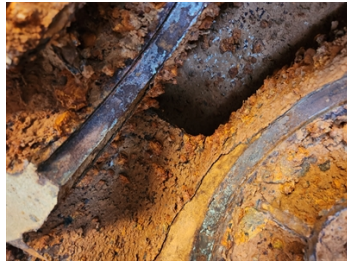
Close up of corrosion damage

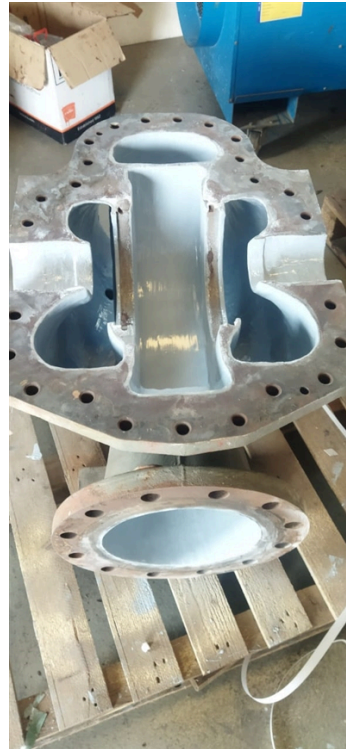
Pump after rebuilding and coating

The application was carried out in accordance with Belzona Know-How System Leaflet CEP-01 and CEP-03.

Belzona solution saved the pump that was out of service and had to be replaced, already saving \$20,000. Without using special tools, Belzona filled pitting, repaired ring areas and impeller damage. The project costed only 30% of the original pump price.

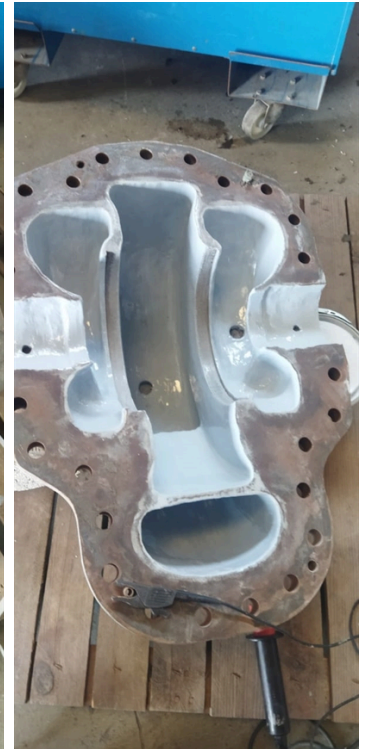
Another angle shot after application
