Refurbishment of Drinking Water Split Casing Pump

ID: 9628

Application: CEP-Centrifugal Pumps

Products: Belzona 1111 (Super Metal), Belzona 1341N (Supermetalglide)

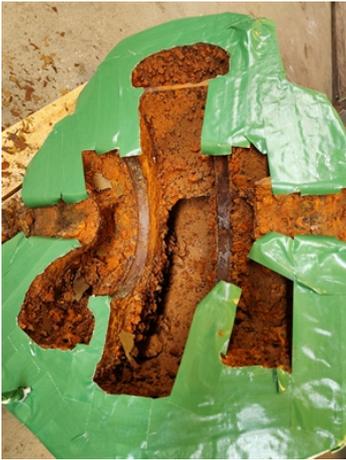
Customer faced corrosion and erosion in the casing of drinking water pump and it was unusable before Belzona repair.

Pump condition before application

For the surface preparation, the pump was blasting to remove all the rust and contamination from the surface, achieving a minimum profile of 75 microns and Near White Metal cleanliness.

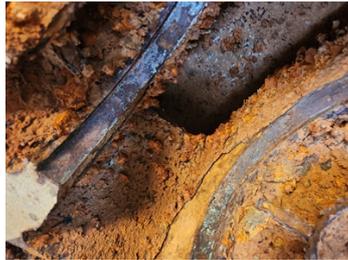
Close up of corrosion damage

Belzona solution saved the pump that was out of service and had to be replaced, already saving \$20,000. Without using special tools, Belzona filled pitting, repaired ring areas and impeller damage. The project costed only 30% of the original pump price.

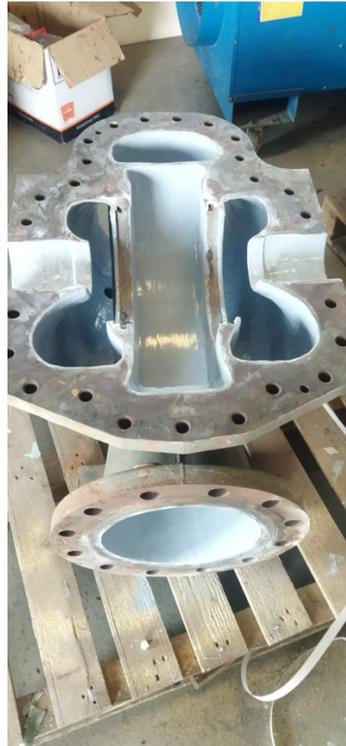
Pump after rebuilding and coating

The application was carried out in accordance with Belzona Know-How System Leaflet CEP-01 and CEP-03.

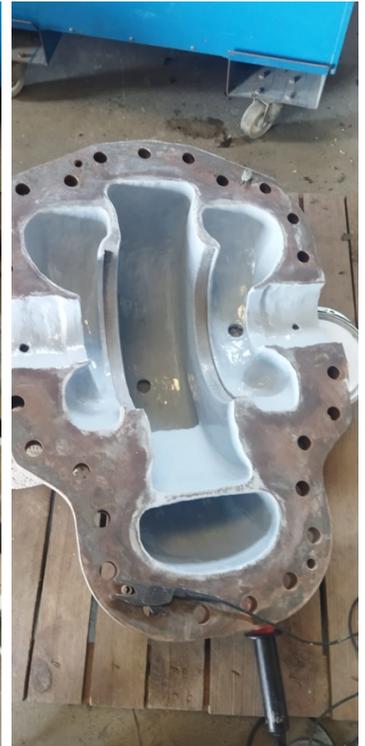
Another angle shot after application
