Repeated Coating of Split Casing Pump for Drinking Water

ID: 9629

Application: CEP-Centrifugal Pumps

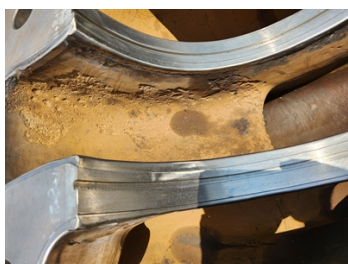
The pump owner was faced with the problem of erosion-corrosion inside the pump, causing pitted areas in the internal surface every two years. To solve this problem, Belzona's pump solution with rebuilding and coating was used.

Pitting damage on the pump casing

For the surface preparation, the pump was blasted to achieve a minimum profile of 75 microns and Near White Metal. Pitting and damages were rebuilt using Belzona 1111, and then 2-coat system of Belzona 1341N was applied in accordance with the Instruction For Use.

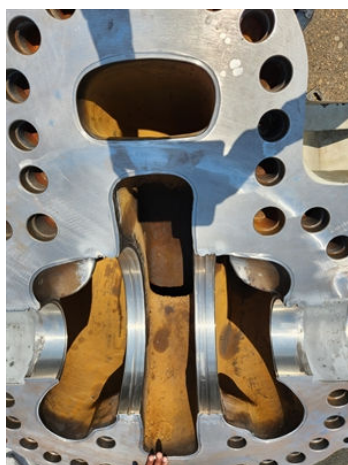
Pump casing before application

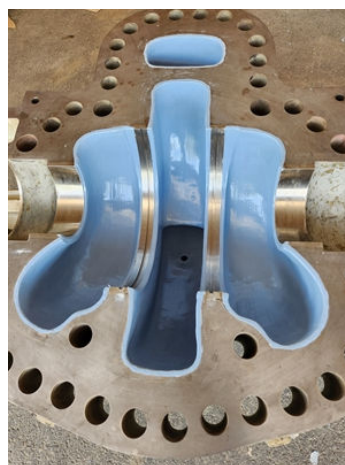
Pump casing protected with Belzona pump coating
