# BELZONA REPAIRS AND PROTECTS SULPHURIC ACID BUND

**Industry:** Power  
**Application:** TCC-Tanks and Chemical Containment Areas  
**Substrate:** Concrete  
**Products:** \* Belzona® 4311 (Magma CR1) ,  
\* Belzona® 4111 (Magma Quartz) ,

**Customer Location:** Power Station, UK  
**Application Date:** December 2007

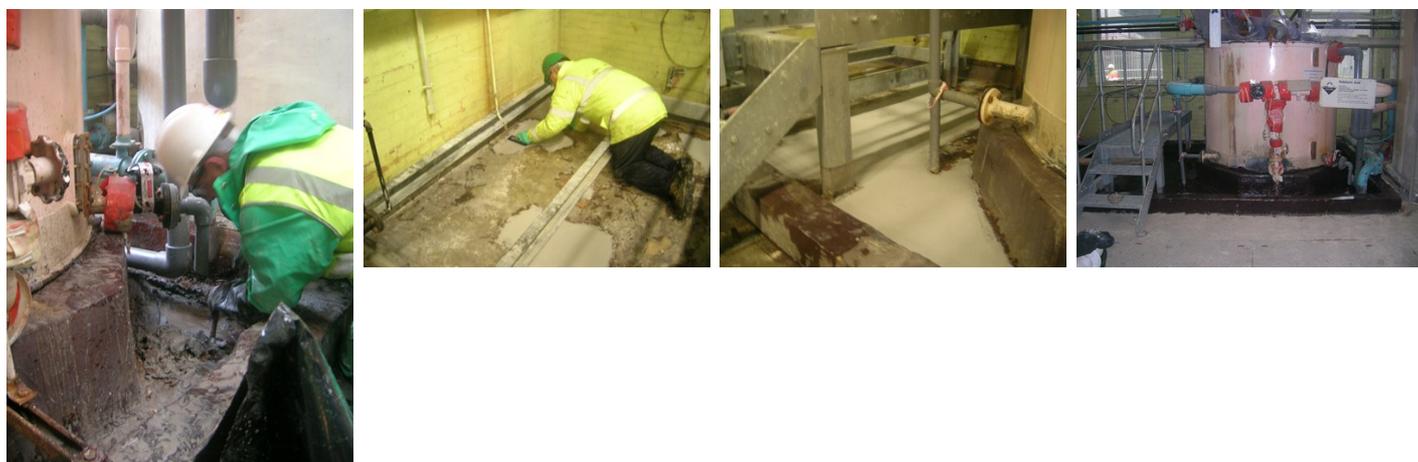
Malfunction in the system caused a quantity of 98% Acid to be dropped, followed by a quantity of distilled water. The resultant exothermic reaction was so rapid it stripped the original coating off the concrete substrate throughout the containment area.

- \* Damaged tank pad ,
- \* Rebuilding with Belzona® 4111 ,
- \* Rebuilding complete ,
- \* Tank pad protected with Belzona® 4311 ,

Secondary containment for two acid tanks in the water treatment section. The top tank contains 98% Sulphuric Acid that feeds into a lower tank diluted to 10% strength, and used in the water treatment process.

Application was carried out in accordance with Belzona Know-How System Leaflets TCC-9 and TCC-15.

No alternative considered since the manager of the plant is very happy with both the Belzona materials and the application by the approved contractor. Belzona coating provides long term protection from 98% Sulphuric acid.
