BELZONA REPAIRS AND PROTECTS SULPHURIC ACID BUND

Industry: Power
Application: TCC-Tanks and Chemical Containment Areas
Substrate: Concrete
Products: * Belzona® 4311 (Magma CR1) ,
* Belzona® 4111 (Magma Quartz) ,

Customer Location: Power Station, UK
Application Date: December 2007

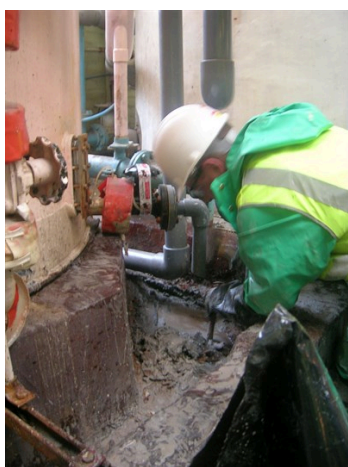
Malfunction in the system caused a quantity of 98% Acid to be dropped, followed by a quantity of distilled water. The resultant exothermic reaction was so rapid it stripped the original coating off the concrete substrate throughout the containment area.

- * Damaged tank pad ,
- * Rebuilding with Belzona® 4111 ,
- * Rebuilding complete ,
- * Tank pad protected with Belzona® 4311 ,
