Belzona protect Spent Caustic Reactor

ID: 9631

Industry: Chemical & Petrochemical
Application: TCC-Tanks and Chemical Containment Areas
Substrate: Carbon steel
Products: Belzona 1511 (Super HT-Metal), Belzona 1593

Customer Location: Dammam, Saudi Arabia
Application Date: June 2024

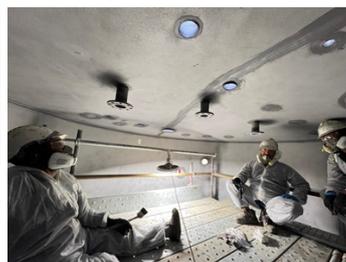
The customer relied on the reactor to treat spent caustic, but the old lining system had failed, causing frequent shutdowns that resulted in losses of \$20,000 per day. To address this issue, we recommended Belzona 1593 as a durable and effective solution.

Internal reactor body before coating

The old coating was removed, and the surface was prepared through blasting to achieve a minimum profile of 75 µm and a near-white metal finish. Belzona 1511 was applied to smooth out welding joints, while Belzona 1593 was used to coat and protect the entire reactor.

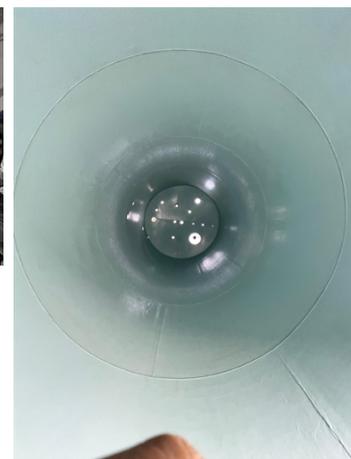
Close-up of the reactor manhole showing damage and corrosion of spent caustic over metal.
