Belzona helps to repair VRM crusher bearing housing

Industry: Cement
Application: ENC-Engines and Casings
Substrate: Cast Iron
Products: Belzona 1121 (Super XL-Metal), Belzona 9411 (Release Agent)

Customer Location: Al Hfouf Plant
Application Date: January 2023

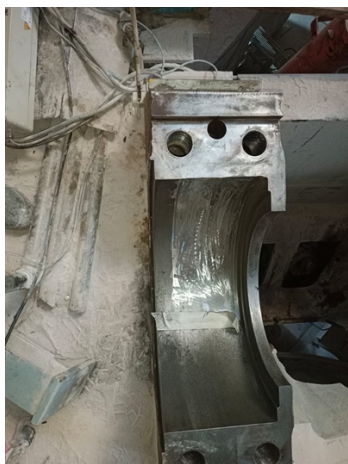
Excessive vibrations in the VRM crusher led to damage in the bearing housing, resulting in wear between the housing and the bearing. This wear ultimately caused bearing failure, leading to the shutdown of the crusher.

Bottom side of the bearing housing before the repair of Belzona

Using Belzona release agent and Belzona 1121, the old bearing was utilized as a former to restore the damaged/worn area to its original profile. Surface preparation was carried out using power tools to achieve the minimum profile recommended by Belzona

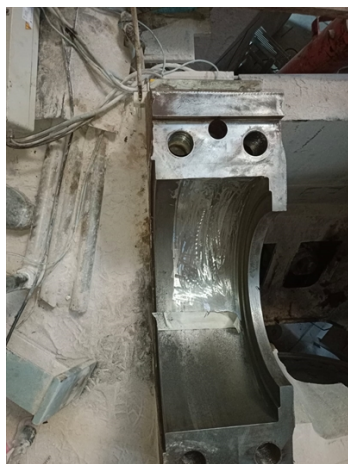
Bearing housing suffered wear and metal loss

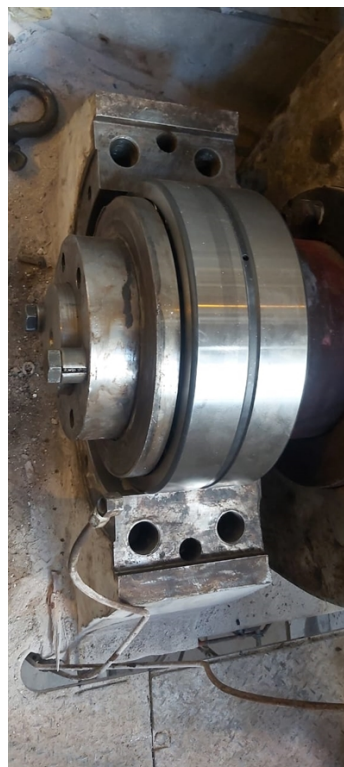
VRM crusher bearing housing in operation

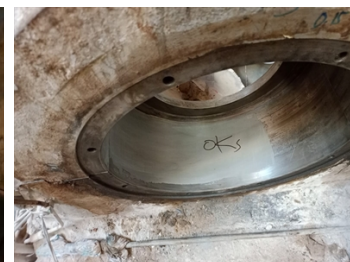
Belzona 1121 (Super XL-Metal) repairs the crusher bearing housing
