# Belzona helps to repair VRM crusher bearing housing

Industry: Cement

Application: ENC-Engines and Casings

Substrate: Cast Iron

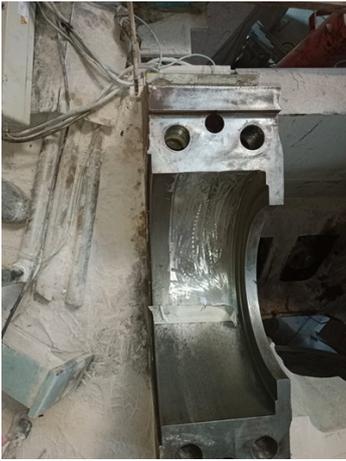
Bottom side of the bearing housing before the repair of Belzona

Using Belzona release agent and Belzona 1121, the old bearing was utilized as a former to restore the damaged/worn area to its original profile. Surface preparation was carried out using power tools to achieve the minimum profile recommended by Belzona

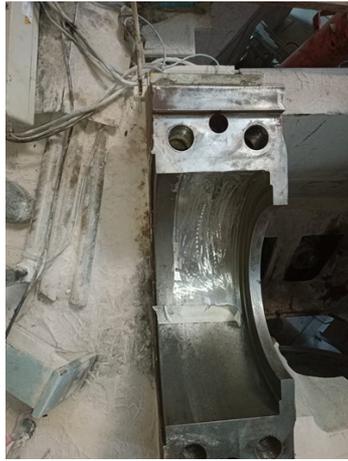
Excessive vibrations in the VRM crusher led to damage in the bearing housing, resulting in wear between the housing and the bearing. This wear ultimately caused bearing failure, leading to the shutdown of the crusher.

Bearing housing suffered wear and metal loss

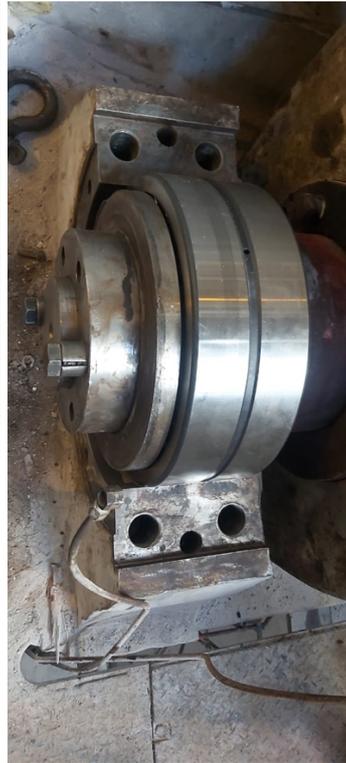
VRM crusher bearing housing in operation

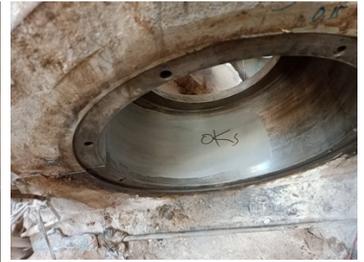
Belzona 1121 (Super XL-Metal) repairs the crusher bearing housing
