Feed Rotor for CHP plant protected

ID: 9633

Industry: *Power*
 Application: *PDP-Positive Displacement Pumps*

Customer Location: *Newark UK*
 Application Date: *October 2024*

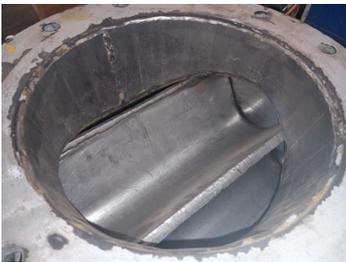
A stainless Fuel feeding rotor had suffered wear and damage, creating issues with leaks, back pressure and unwanted vacuums in the feeder process to the boiler in an industrial CHP (Combined Heat and Power plant)

The rotor whilst still in it's original housing

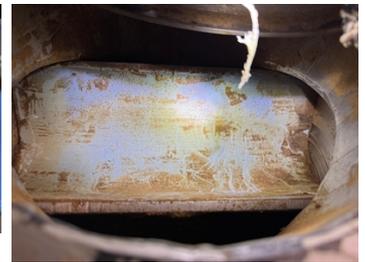
1 year on and the coating is still perfect, doing exactly as intended by avoiding build up of material and allowing the rotor to perform at full efficiency, whilst protecting against erosion

1st coat Belzona 1341 applied at 250µm

2nd coat Belzona 1341 applied at 250µm
