Refurbishment of Energy From Waste Process Plant

ID: 9634

Industry: Commercial Facilities
Application: TCC-Tanks and Chemical Containment Areas
Substrate: Carbon steel
Products: Belzona 1593

Customer Location: St Austell, Cornwall
Application Date: November 2023

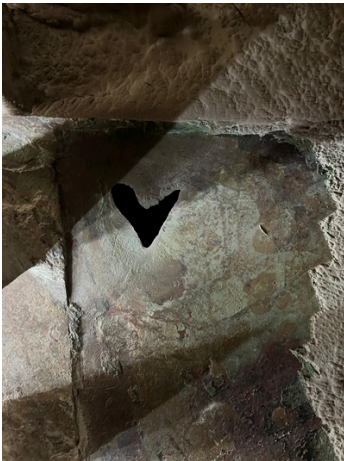
Customer was suffering severe internal corrosion within their process plants pillenium & re-circulation channels. This was due to high concentrations of Calcium Oxide (37%) and Chlorine (26%) operating at temperatures of 140 Deg. C.

Internal through hole defect.

Where required, plates were bonded into place on through hole defects where required using a Belzona paste grade. Belzona 1593 was then applied to the repaired areas.

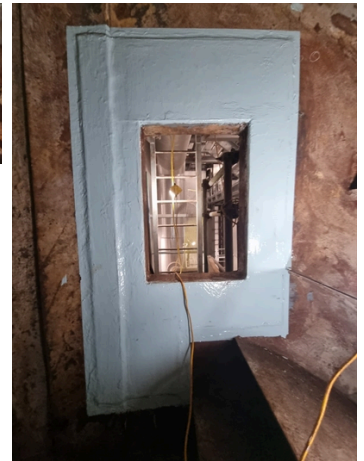
Plate bonding and coating of localised defect.

The preparation was carried out by grit blasting to Belzona's IFU Specification sheets for the products.
