Refurbishment of Energy From Waste Process Plant

ID: 9634

Industry: Commercial Facilities
Application: TCC-Tanks and Chemical Containment Areas
Substrate: Carbon steel
Products: Belzona 1593

Customer Location: St Austell, Cornwall
Application Date: November 2023

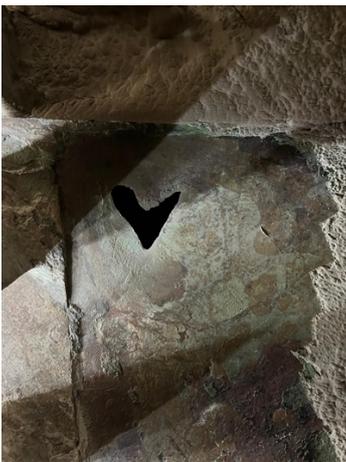
Customer was suffering severe internal corrosion within their process plants pillenium & re-circulation channels. This was due to high concentrations of Calcium Oxide (37%) and Chlorine (26%) operating at temperatures of 140 Deg. C.

Internal through hole defect.

Where required, plates were bonded into place on through hole defects where required using a Belzona paste grade. Belzona 1593 was then applied to the repaired areas.

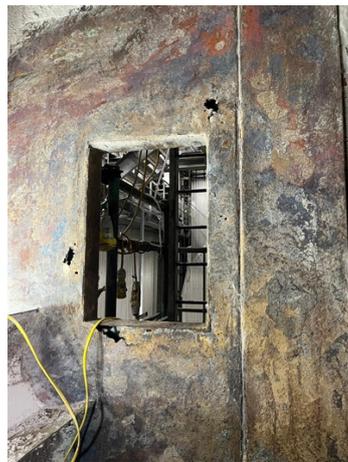
Holed & corroded section of internal system.
