# Balconies and stairwells Improvements

ID: 9635

Application: FPA-Floor Problem Areas

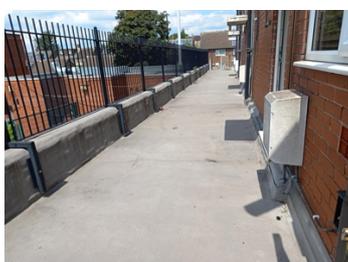
Multiple issues needed to be addressed in this large project where 2 groups of 5 flats had issues with spalling concrete to stairwells, unsafe, broken and slippery concrete stairs, spalling concrete in the stairwells and leaking bitumen on the balconies above. The stairwell brickwork also required sealing

Bitumen Balconies letting in water to structures below

Access was enabled to the flats using boards and a system where half the balconies were coated with the Belzona 3131 at a time, including the total blinding of Belzona 9231 Surefoot aggregate

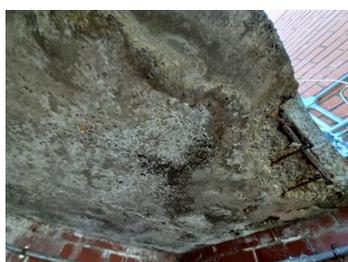
Stairwells showing severe spalling with possibility of falling concrete

All the spalling areas were hammer tested, cleaned and repaired using Belzona 4141 and Belzona 4131

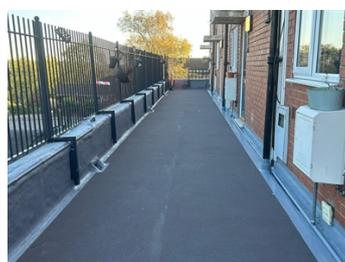
Balconies fully coated with the addition of Belzona Surefoot aggregate

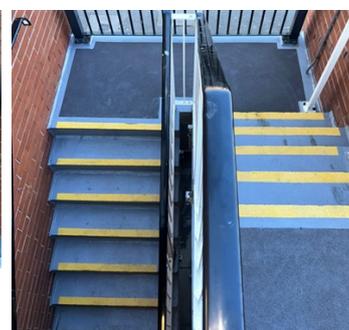
Stairwells repaired, a low slip coating added with Belzona Granogrip step edgings and all brickwork sealed with Belzona 5122 clear cladding

The concrete stairs were prepared and coated with Belzona 5231, prior to the nose edging being coated with Belzona Granogrip in

Finally all the walls in the stairwells were coated with Belzona 5122 Clear cladding to assure a water tight finish and protect the brickwork
