# Corroded rotor and end covers

Industry: *Marine*  
Application: *CEP-Centrifugal Pumps*  
Substrate: *Cast Iron*  
Products: *Belzona 1111 (Super Metal), Belzona 1331*

Customer Location: *Houma*  
Application Date: *October 2024*

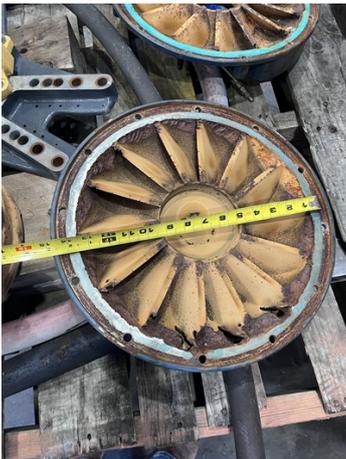
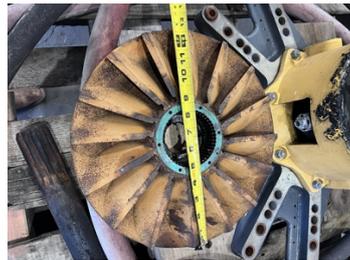
*Rotor and end covers corroded due to harsh saltwater environment.*

End covers before application. Rotor before application.

Abrasive blasting was performed to create a bonding surface essential for Belzona 1111 to be applied.
