Leaking water line repaired with Belzona 1161 and 1212

ID: 9637

Industry: Chemical & Petrochemical
Application: VPF-Valves, Pipes and Fittings
Substrate: Carbon steel
Products: Belzona 1161 (Super UW-Metal), Belzona 1212

Customer Location: Geismar
Application Date: October 2024

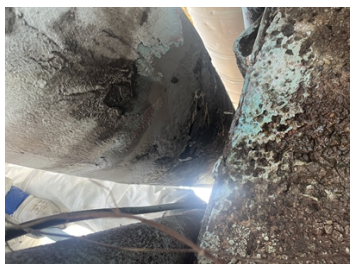
Customer had a significant leak on a 12" supply water line. The water line was corroded at the pipe support base, with multiple hole through locations.

Corroded pipeline.

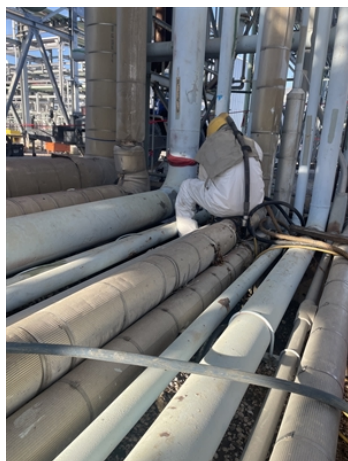
Application of Belzona 1161.

Cold plate bond using Belzona 1212, then wrapping with Belzona 9341 Reinforcement Sheet with Belzona 1161

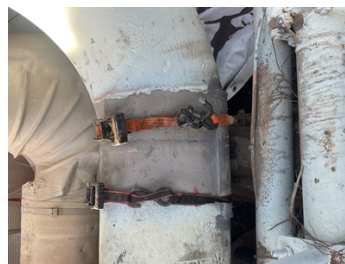
Application of cold bonded plate with Belzona 1161.

Customer Called late afternoon on a Friday with this pipe leak, Belzona was able to mobilize and be on site within an hour. the application crew was able to plate bond over the multiple holes in pipe and then we wrap over the plate to secure plate and stop any future leaks. Customer was able to fill line back up in a matter of a few hours saving them days of down time and also saving money

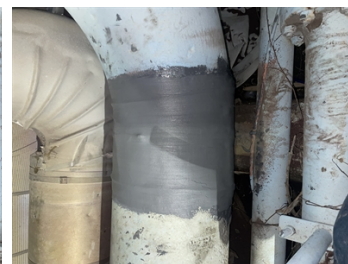
Finished application with Belzona 1212.
