Leaking water line repaired with Belzona 1161 and 1212

ID: 9637

Application: VPF-Valves, Pipes and Fittings

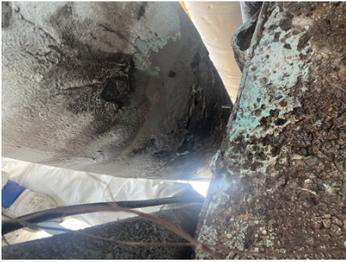
Customer had a significant leak on a 12" supply water line. The water line was corroded at the pipe support base, with multiple hole through locations.

Corroded pipeline.

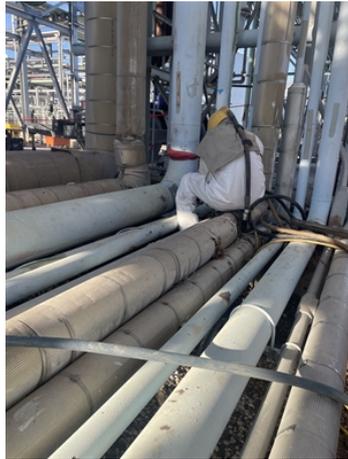
Application of Belzona 1161.

Cold plate bond using Belzona 1212, then wrapping with Belzona 9341 Reinforcement Sheet with Belzona 1161

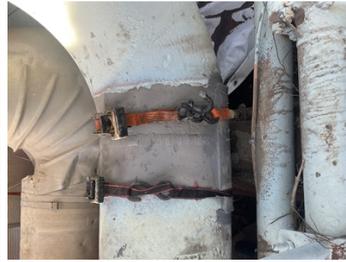
Application of cold bonded plate with Belzona 1161.

Customer Called late afternoon on a Friday with this pipe leak, Belzona was able to mobilize and be on site within an hour. the application crew was able to plate bond over the multiple holes in pipe and then we wrap over the plate to secure plate and stop any future leaks. Customer was able to fill line back up in a matter of a few hours saving them days of down time and also saving money

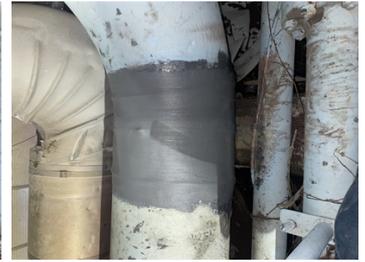
Finished application with Belzona 1212.
