Sea Water Valve Refurbishment

ID: 9638

Application: *VPF-Valves, Pipes and Fittings*

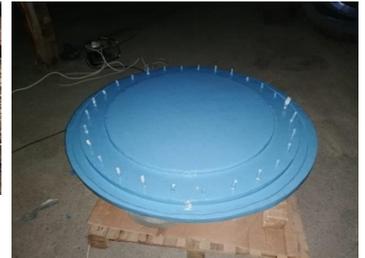
Belzona 1111 (Super Metal) rebuilt the damaged metal surface

1. Rebuild the worn metal with Belzona 1111 (Super Metal)
2. Machine to the original dimensions to get a proper seal area
3. Overcoat the part with Belzona 1341 (Supermetalgilde)
