# Belzona provides Internal pump refurbishment with ceramic coating system

Application: CEP-Centrifugal Pumps

Application Date: September 2023

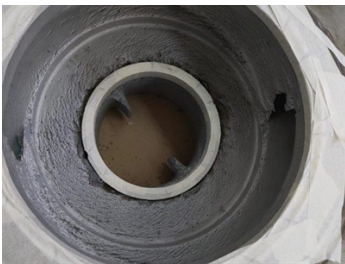
The pump suffered severe erosion caused by high solid content in the fluid

Erosion evidence on pump component due to high solid content

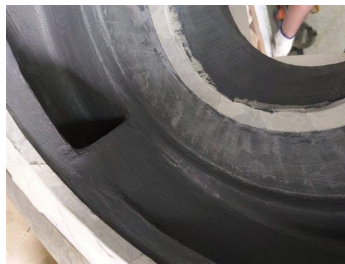
Surface preparation on the pump before the application of Belzona system

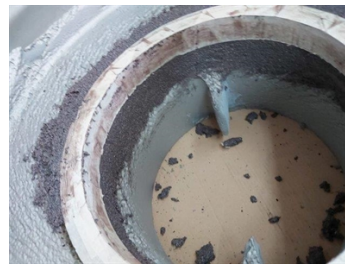
Pump surface was rebuilt with Belzona 1311 (Ceramic R-Metal)

1. Apply Belzona 1311 to rebuild the worn-out metal
2. Overcoat the rebuilt pump with Belzona 1321 (Ceramic S-Metal)

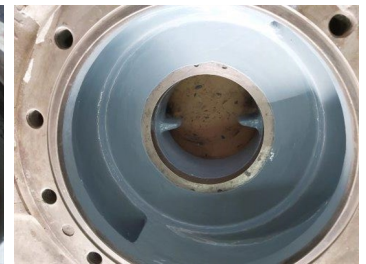
Once the surface was rebuilt, Belzona 1321 (Ceramic S-Metal) was applied to enhance protection and prevent further damage.
