# BELZONA SMOOTHS OUT DAIRY RAMP

Industry: *Buildings & Structures*  
 Application: *FPA-Floor Problem Areas*  
 Substrate: *Ceramic Tiles*  
 Products: *Belzona® 4111 (Magma Quartz)*

Customer Location: *Dairy, Telford, UK*  
 Application Date: *2007*

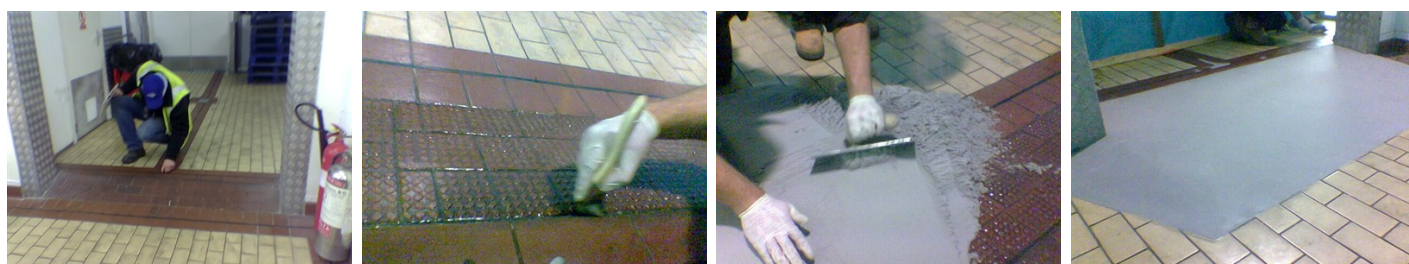
## Photograph Descriptions

*The slope was causing product being transferred from section to section by electric hand truck to be both unstable on the pallets and a safety hazard when travelling down the slope.*

\* Inspection of ramp prior to work , \* Application of Conditioner prior to Belzona® 4111 , \* Application of Belzona® 4111 begins , \* The finished ramp ,

The factory has grown over a number of years with each new section at different floor levels. The area in question had a very short steep ramp between the creamery and the store area.

Application was carried out in accordance with Belzona Know-How System Leaflet FPA-1. A sponge was used to produce a slightly rough finish for slip reduction.

The Factory works non-stop and the safety issue could not wait for a shutdown. The window to work in was very short, 36 hours maximum. Client chose Belzona on grounds of technical support ensuring application completed in tight time frame. The ramp looks as good as new more than 12 months later.
