Pipe Girth Weld Internal Coating

ID: 9640

Industry: Oil & Gas
Application: VPF-Valves, Pipes and Fittings
Substrate: Carbon steel
Products: Belzona 1391T

Customer Location: Saudi Arabia
Application Date: June 2021

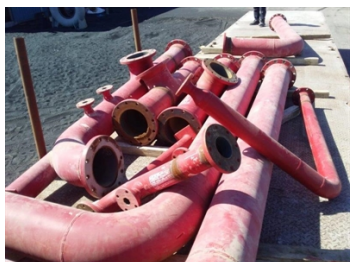
Pipes are coated with Fusion Bonded Epoxy Coating (FBE) from manufacture but after welding, the fitting FBE coating got burned and needed repair.

Damaged pipe girth

1. Do grit blasting to remove the burned coating until the required profile and cleanliness is achieved.
2. Apply Belzona 1391T onto the internal fitting.
3. Spark testing to detect if there are any pinholes.

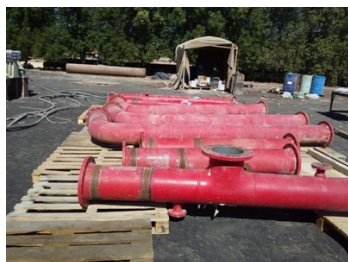
Damaged pipe girth needed repair

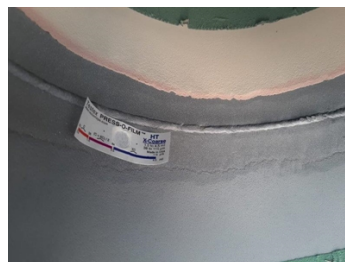
Measuring the surface roughness before starting Belzona application
