# Pump Housing Repair and Coat

ID: 9641

Application: PDP-Positive Displacement Pumps

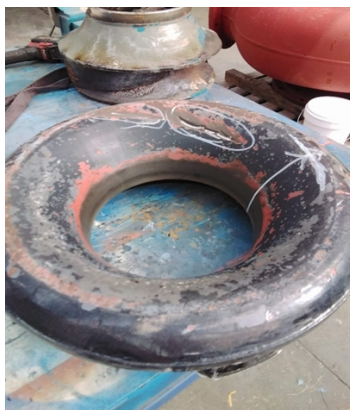
Customer had issues with pump housing getting severely eroded in service.

Damaged pump housing.

Due to the damage of the pump housing, repair was required urgently with a lead time on a new pump been quite long. A Belzona repaired offered a fair quicker long term repair solution with a 1-2 week lead time.

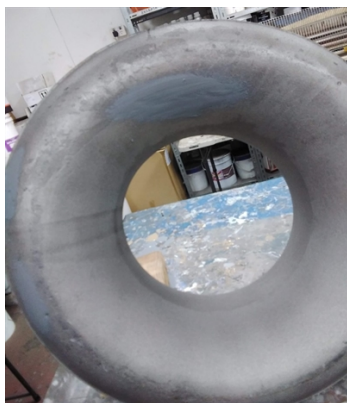
Pump housing abrasive blasted and Belzona paste grade metal utilised to repair erosion.

Pump housing was abrasive blasted to a S.A 2.5 standard (75 micron) profile before all eroded sections been rebuilt with Belzona 1311 paste grade metal. There after 2 coats of Belzona 1321 was applied for long term protection against erosion.

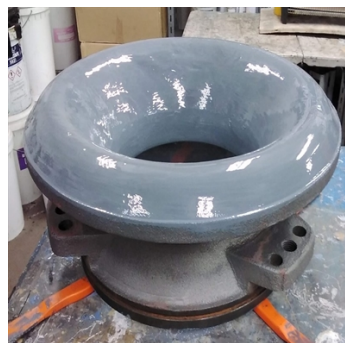
First coat of Belzona 1321 applied.

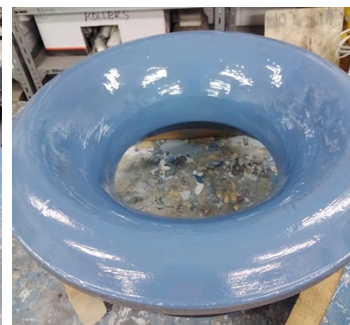
Pump housing complete with final coat of Belzona 1321.
