Lining of a yacht's diesel tanks

ID: 9645

Application: *TCC-Tanks and Chemical Containment Areas*

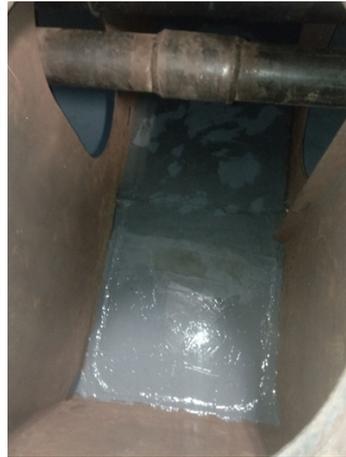
Application of Belzona 1311 to rebuild pitted areas

Before 1311 was applied to the substrate after it was grit blasted. The lining material was Belzona 1321.
