Belzona improves efficiency of cooling water circulation system centrifugal pump

ID: 9646

Application: CEP-Centrifugal Pumps

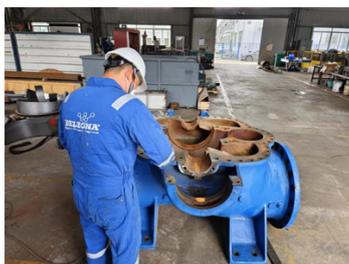
Degreasing and chamfering pump casing surface

The application was carried out in accordance with Belzona System Leaflet CEP-10. First, all sharp edges were grounded to give a radius of not less than 3 mm and the matching surfaces were protected. Then, grit blasting was performed. After cleaning, Belzona 1111 was used to repair and fill pits. Belzona 1341 coating was used for protection and efficiency improvement. After completion, the impeller was dynamically balanced.

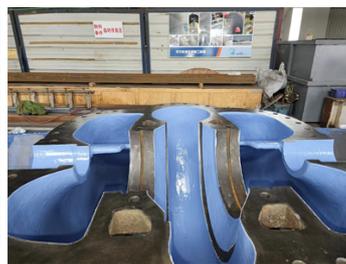
2 coatings of Belzona 1341 completed

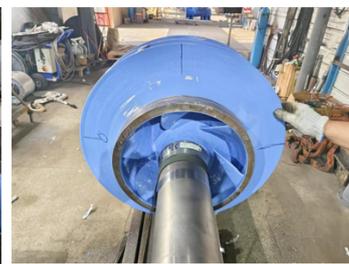
Dynamic balancing test after the impeller is coated with Belzona 1341

Belzona 1341 can be used to improve pump efficiency. After using this solution, the Customer conducted energy consumption monitoring for 2 months and was highly satisfied with the results. The monitoring data after repairing one of the 5 pumps in the system: the power of a single pump was saved by 1.87%, and the flow of the entire system increased by 2.8%. After using this Belzona solution, the Customer found that it could save more than 100,000 RMB in energy consumption costs each year. According to the Customer's calculation, if the entire system is coated with energy-saving and efficiency-enhancing Belzona coatings, it can save more than 1 million RMB in energy consumption costs per year.
