# Stress Corrosion Cracked Filter Stripper

ID: 9647

**Industry:** Chemical & Petrochemical  
**Application:** TCC-Tanks and Chemical Containment Areas  
**Substrate:** Carbon steel  
**Products:** Belzona 1511 (Super HT-Metal), Belzona 1593

**Customer Location:** Plaquemine, Louisiana  
**Application Date:** September 2024

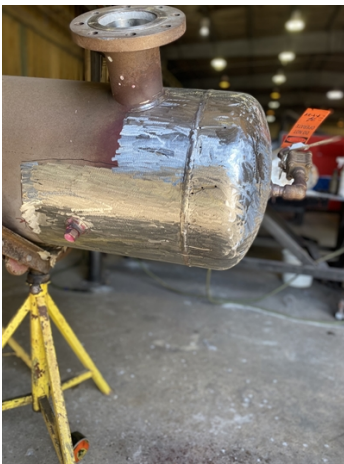
Surface preparation of areas of repair, all identified cracks terminated as per system leaflet TCC-1

TCC-1 procedure was used to address all identified cracks. Surface preparation was carried out using grinder and final profile achieved utilizing MBX surface profiling tool. Upon completion of application the unit was force/poste cured as per Product manufactures recommendations in order to return to service requirements within 24 hrs.

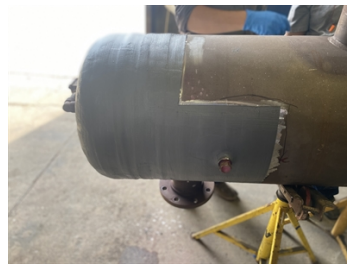
Application of 1511/ 9341 Reinforced system to bottom Head and extending 6" outside defect area.

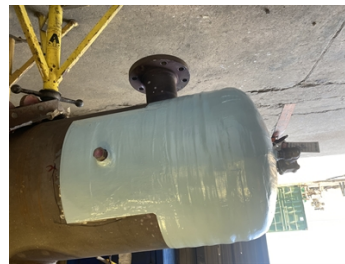
Additional protection provided by application of additional 1593/9341 reinforced system.

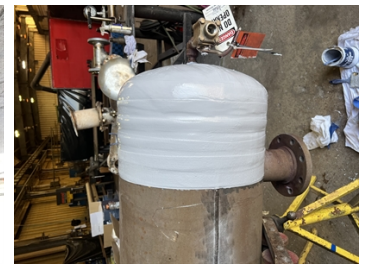
Completion of 1593/9341 reinforced system.
