Stress Corrosion Cracked Filter Stripper

ID: 9647

Customer Location: Plaquemine, Louisiana
Application Date: September 2024

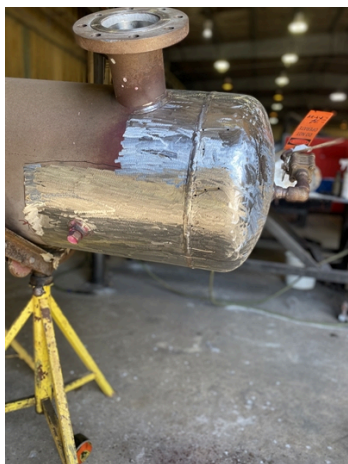
Surface preparation of areas of repair, all identified cracks terminated as per system leaflet TCC-1

TCC-1 procedure was used to address all identified cracks. Surface preparation was carried out using grinder and final profile achieved utilizing MBX surface profiling tool. Upon completion of application the unit was force/postcured as per Product manufactures recommendations in order to return to service requirements within 24 hrs.

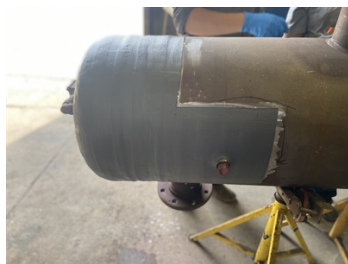
Application of 1511/ 9341 Reinforced system to bottom Head and extending 6" outside defect area.

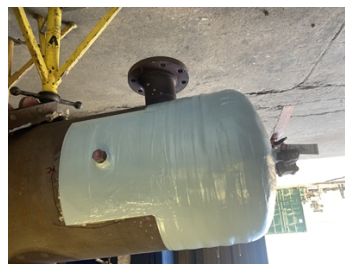
Additional protection provided by application of additional 1593/9341 reinforced system.

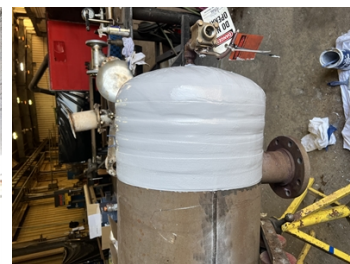
Completion of 1593/9341 reinforced system.
