Stress Corrosion Cracked Filter Stripper

ID: 9647

Industry: Chemical & Petrochemical
Application: TCC-Tanks and Chemical Containment Areas
Substrate: Carbon steel
Products: Belzona 1511 (Super HT-Metal), Belzona 1593

Customer Location: Plaquemine, Louisiana
Application Date: September 2024

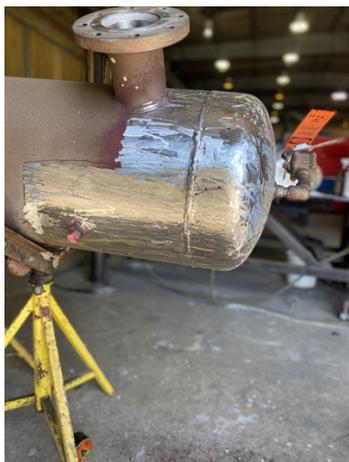
Surface preparation of areas of repair, all identified cracks terminated as per system leaflet TCC-1

TCC-1 procedure was used to address all identified cracks. Surface preparation was carried out using grinder and final profile achieved utilizing MBX surface profiling tool. Upon completion of application the unit was force/poste cured as per Product manufactures recommendations in order to return to service requirements within 24 hrs.

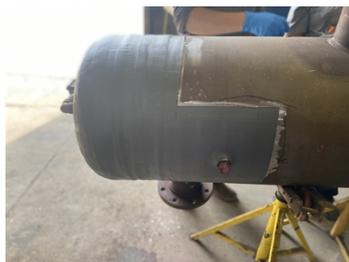
Application of 1511/ 9341 Reinforced system to bottom Head and extending 6" outside defect area.

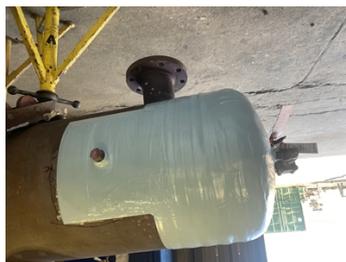
Additional protection provided by application of additional 1593/9341 reinforced system.

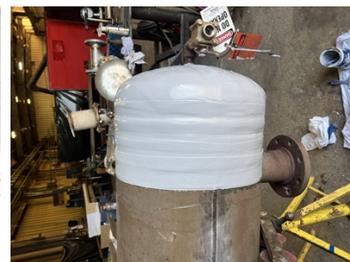
Completion of 1593/9341 reinforced system.
