# Cold Bonding Pipe Support Brackets to Tank

ID: 9648

Industry: Oil & Gas  
Application: TCC-Tanks and Chemical Containment Areas  
Substrate: Stainless-steel  
Products: Belzona 7311

Customer Location: Geismar, Louisiana  
Application Date: August 2024

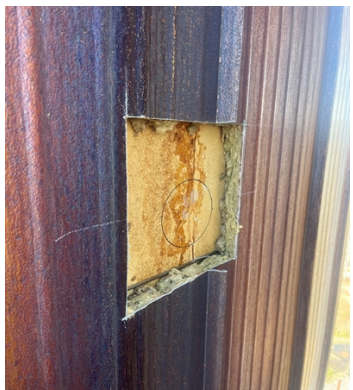
Client identified and marked where support to be bonded on tank exterior.

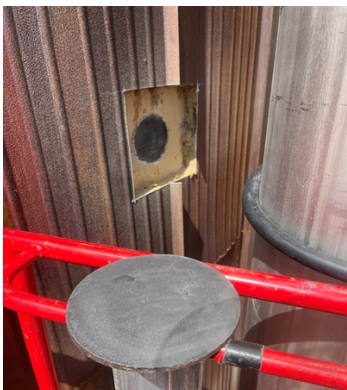
Pipe support and bond area perspiration.

Application was carried out with all surface preparation executed with TFT Pneumatic Rough Boy sparkless profiling tool. Therefore, eliminating any hot work in areas and potential damage to internal liner of vessel.

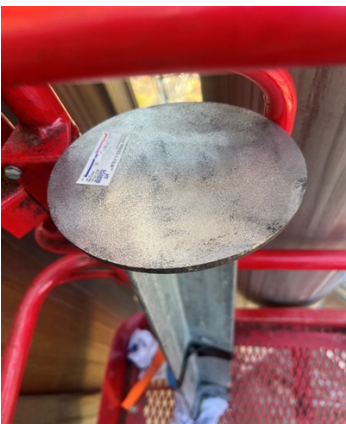
Pipe support bond pad surface profile readings were taken prior to bonding.

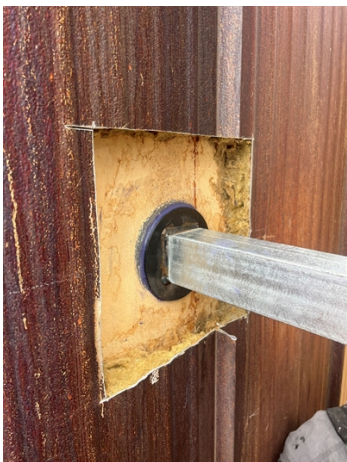
Pipe support bonded to prepared tank substrate Belzona 7311.

Belzona 7311 was chosen as an alternative to welding. Belzona 7311 repair also offered the ability to cold bond the pipe support without the need for open flame hot work and possible damage internal liner of vessel.
